2014 ANNUAL WATER QUALITY REPORT

WESTHILLS WATER SYSTEM

Operated by SSL-Sustainable Services Ltd.

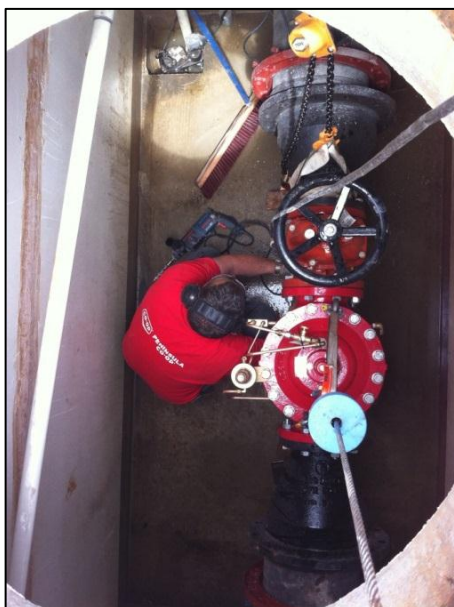
Pressure Relief Valve

- Delivered 134,698 m³ of water to the Westhills community;
- Provided 93,134 m³ of water to Westhills residents;
- Provided 31,658 m³ of water usage to public works, parks and commercial space;
- Conducted 24 microbiological tests;
- Maintained 1 pressure relief valve;
- Maintained 38 fire hydrants to ensure water is available during an emergency;
- Detected zero leaks in water mains.

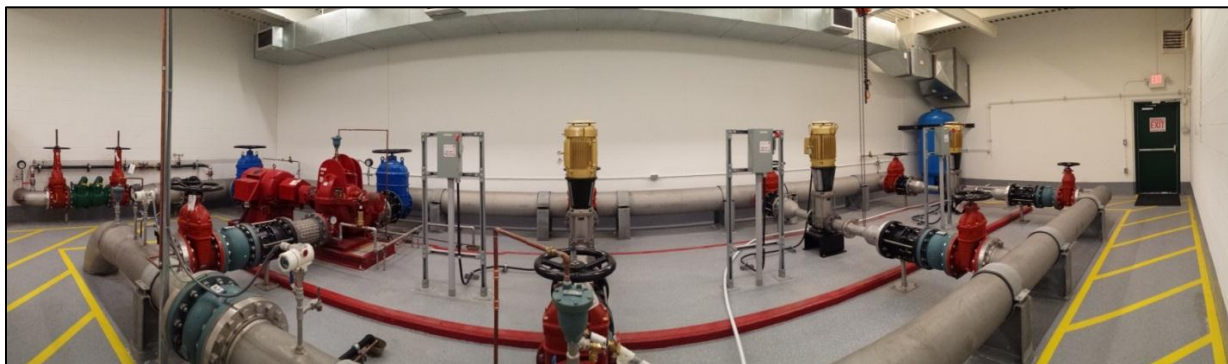
Booster Pump Station

Water is then pumped through 3 high-efficiency variable speed pumps into a distribution system servicing 346 single family homes, 31 town homes, a 68 unit condominium as well as public irrigation and some commercial end uses. An automatic fire pump within the BPS provides fire flows when needed. The BPS also includes a standby diesel generator for emergency conditions. Fuel supply for this generator is fed from a day tank, which is in turn fed from a larger underground storage tank. An overview of significant water system assets can be seen in Table 1.
