2015 ANNUAL WATER QUALITY REPORT

WESTHILLS WATER SYSTEM

Operated by SSL-Sustainable Services Ltd.

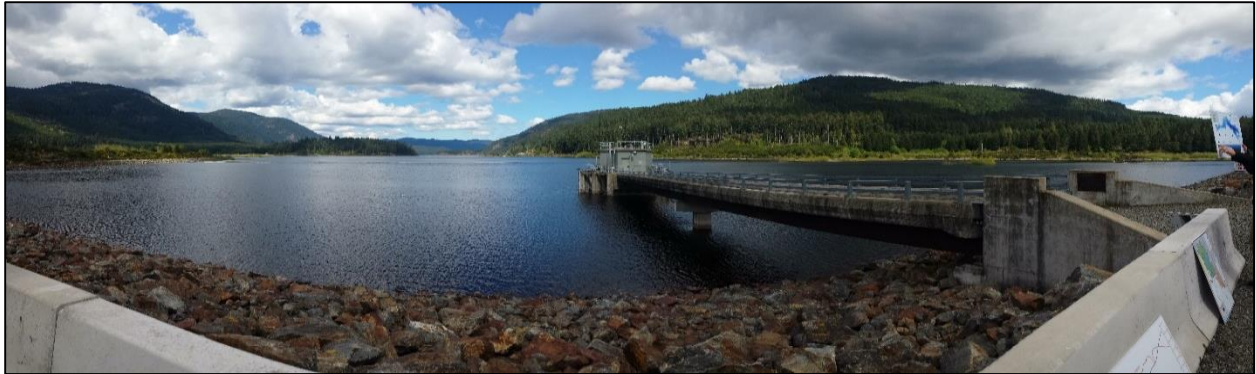
Sooke Lake Reservoir

The main water supply for the Westhills Water System is the Sooke Lake Reservoir, which also supplies water to the majority of the Capital Regional District (CRD)³. This water source is managed by CRD Integrated Water Services, including all disinfection and treatment processes – notably UV sterilization and chloramination.

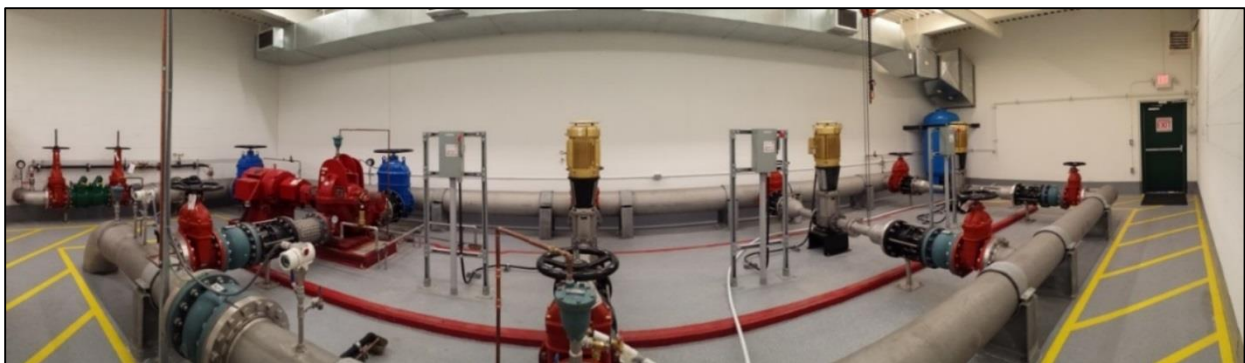
Booster Pump Station

Water is then pumped through 3 high-efficiency variable speed pumps into a distribution system servicing 388 single family homes, 33 town homes, a 68-unit condominium as well as park and public irrigation and commercial end uses. An automatic fire pump within the BPS provides fire flows when needed. The BPS also includes a standby diesel generator for emergency conditions. Fuel supply for this generator is fed from a day tank, which is in turn fed from a larger underground storage tank. An annual overview of significant water system assets can be seen in Table 1.

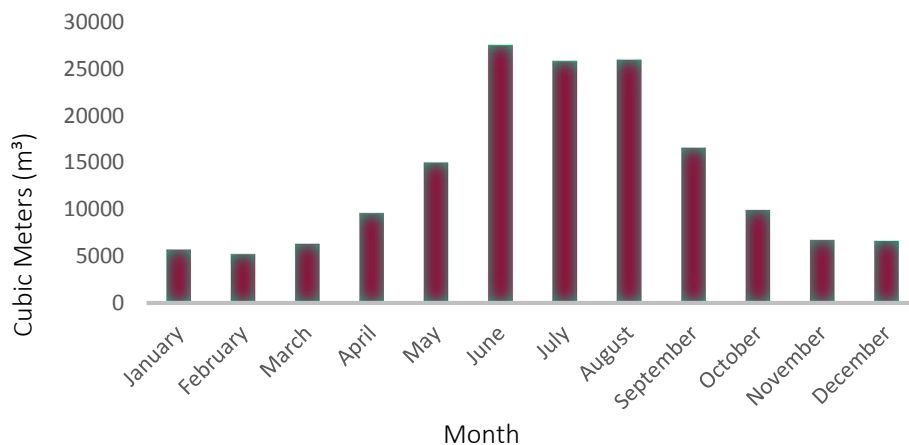
2015 Water Consumption

Like many systems, water usage within Westhills more than triples in summer months compared to average winter usage, as seen in the graph below. Most of this increase is associated with the use of irrigation systems. As an ongoing land development site, large amounts of water are also used in summer months for construction and dust control purposes.

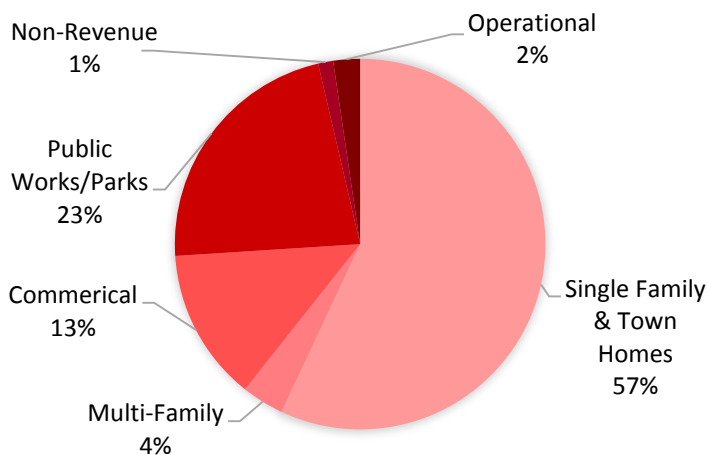
Annual Water Usage Breakdown

The graph below provides a breakdown by end use of all water provided in 2015. Through customer metering, SSL is able to track residential, commercial, parks and operational water usage, which accounts for most of the water which passes through the BPS. It is reasonable to assume that any unidentified portion of the annual water consumption is attributed to “water loss” within the system. This category, also called non-revenue water, includes things like water leaks, error margins for estimated water billings, hydrant usage for fire department training and potentially water theft. In 2015, non-revenue water was 2,110 m³, or about 1% of total water usage in the system. This is significantly better than industry standards and represents an improvement from the 5% figure for 2014. We believe part of this change is due to an improved ability to measure operational water usage.

2014	2015
Single Family & Townhomes	64 %	57 %
Multi Family	5 %	4 %
Commercial	5 %	13 %
Public Works/Parks	18 %	22 %
Non-Revenue	6 %	1 %
Operational	2 %	2 %

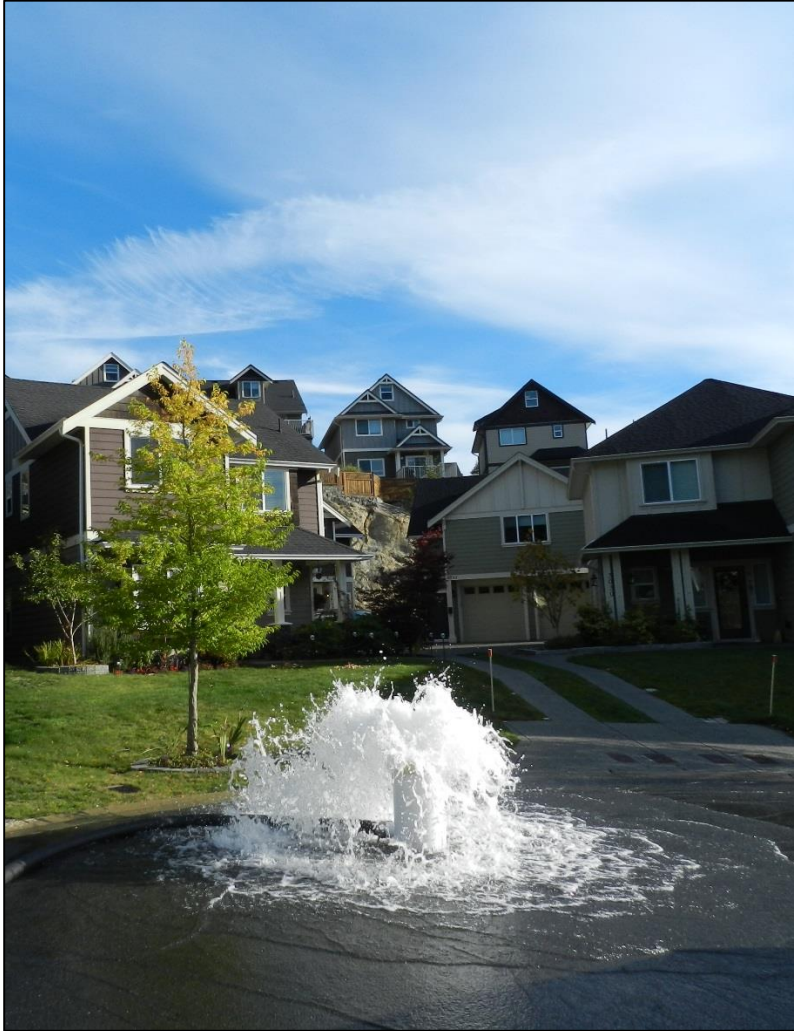
Unidirectional Flushing

- Unidirectional flushing: Full system (annual); low-demand or dead-end sections (semi-annual)
- Fire hydrants: Pressure testing, painting, physical inspection and maintenance (annual); data reported to fire department, see Appendix 2.
- Valve exercising: Open/close all system valves to confirm operational; check all box covers and arrow painting (annual)

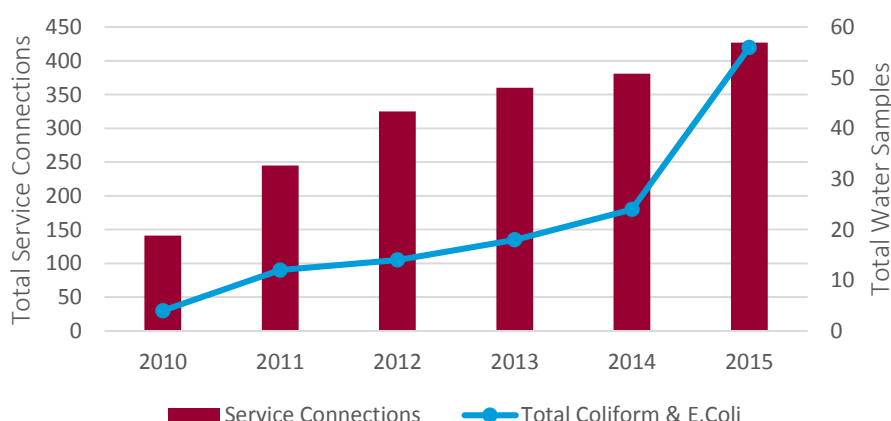
Number of Bacteriological Samples vs Service Connections

In 2015, 3 HPC, 11 Turbidity and 56 bacteriological samples for Total Coliform and E. Coli were collected. Sampling frequency has steadily increased over the years to keep up with the ongoing growth of the Westhills Water System and community, as seen in the graph below. All samples were sent for analysis at Maxxam Analytics laboratory, where tests were conducted in order to detect any potentially harmful parameters in the water.
