# 2016 ANNUAL WATER QUALITY REPORT

WESTHILLS WATER SYSTEM

Operated by SSL-Sustainable Services Ltd.

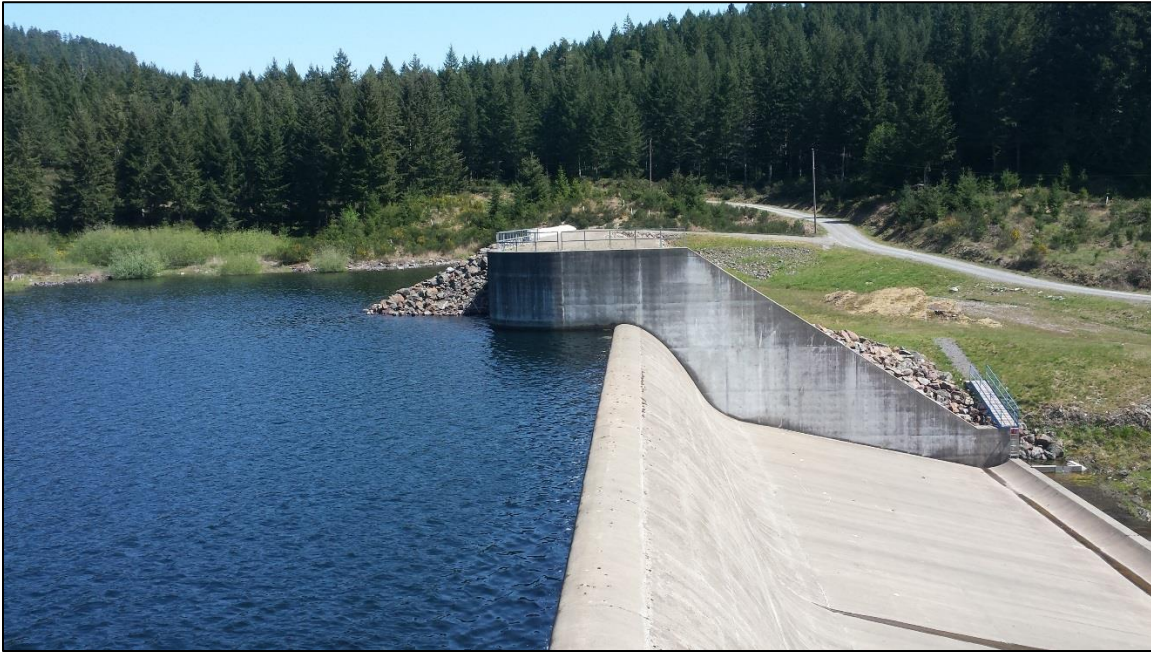
Sooke Lake Reservoir

The main water supply for the Westhills Water System is the Sooke Lake Reservoir, which also supplies water to the majority of the Capital Regional District (CRD)<sup>5</sup>. This water source is managed by CRD Integrated Water Services, including all disinfection and treatment processes – notably UV sterilization and chloramination.

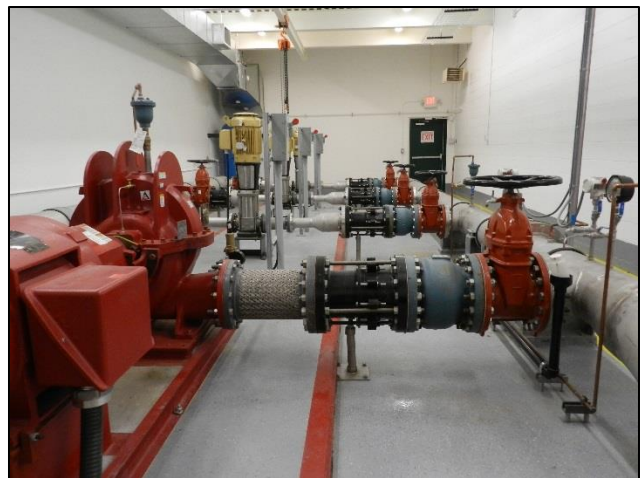
The treated supply water then enters the Humpback Pressure Reducing Station located approximately two kilometers upstream from the Westhills Water System’s Booster Pump Station (BPS). Bulk water is metered inside the Westhills BPS, representing the demarcation point between the regional water system operated by the CRD and the Westhills Water System operated by SSL–Sustainable Services Ltd.

Water is then pumped through 3 high-efficiency variable speed pumps into a distribution system servicing 421 single family homes, 50 town homes, a 68-unit condominium as well as park and public irrigation and commercial end uses. An automatic fire pump within the BPS provides fire flows when needed. The BPS also includes a standby diesel generator for emergency conditions. Fuel supply for this generator is fed from a day tank, which is in turn fed from a larger underground storage tank. An annual overview of significant water system assets can be seen in Table 1.

- Weekly inspections of the BPS are carried out by a certified operator (EOCP Level III), with observations recorded in an on-site log book, including parameters like water temperature, total chlorine residual and pump run hours.
- SCADA/HMI System is remotely accessible from any computer connected to the internet and offers real time readings, trend logs and alarm tracking (authorized users only / protected by dual layer password protection).
- System Alarms are enunciated to a list of on-call personnel through an automated phone line system, which can operate without internet connectivity
- Live Video Cameras record any motion inside and outside the BPS, with both the live feed and recorded footage remotely accessible (authorized users only / protected by password and software registration)

- Fire pump: weekly inspection and 30-minute manual test run; annual inspection and cleaning of pump shaft cooling channels, packing glands and casing gaskets
- Booster pumps: weekly inspection and recording of run hours
- Diesel generator: weekly inspection and automated test run; annual full servicing which includes oil/filter change, readiness test and full load-banking (report filed on site and at SSL office)
- Pressure tank: annual inspection and servicing
- Backflow prevention devices: annual test by certified BFP tester (repair or replace as needed)
- Building electrical systems: annual inspection and report completed by FSR listed on Electrical Operating Permit
- Full hard copy sets of as-built and shop drawings are located at BPS, SSL head office, and with water system operator

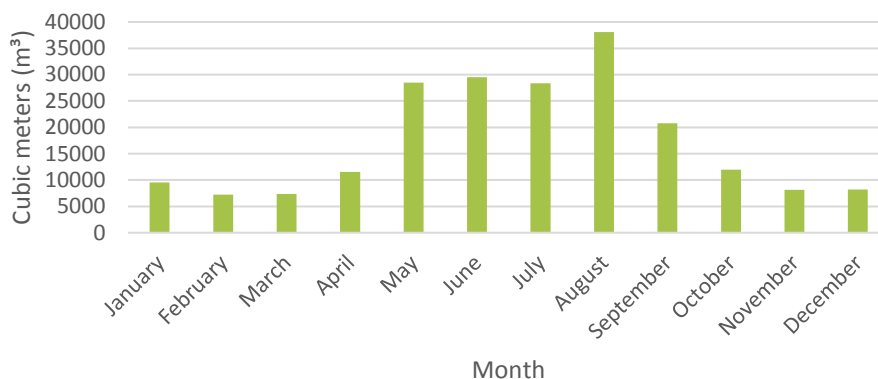
## 2016 Water Consumption

Like many systems, overall water usage more than triples during the summer compared to average winter levels, as seen in the graph below. Most of this increase is associated with the use of irrigation systems. As Westhills is also an ongoing land development site, large amounts of water are used during the dry summer months for construction and dust control purposes.

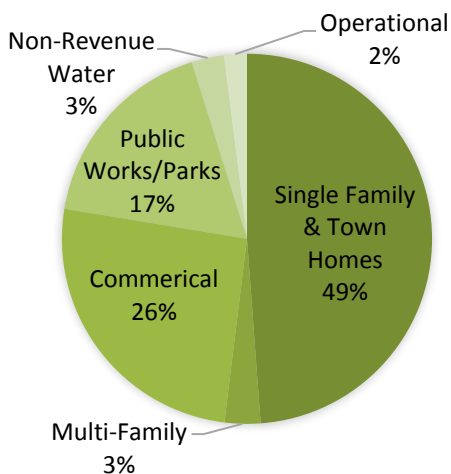
## Annual Comparison

The graph below provides a breakdown by end use of all water provided in 2016. Through customer metering, SSL is able to track residential, commercial, parks and operational water usage, which accounts for most of the water which passes through the BPS. Any unidentified portion of the annual water total is classed as “non-revenue water,” including things like water leaks, error margins for estimated water billings, hydrant usage for fire department training and potentially water theft. In 2016, non-revenue water was 5,873 m<sup>3</sup>, or about 3% of total water usage in the system. While this amount is significantly better than industry standards, it is higher than the 2015 value of 1%. We believe part of this change is due to an increase of water main flushing in 2016, for which usage totals are estimated (i.e. unmetered).

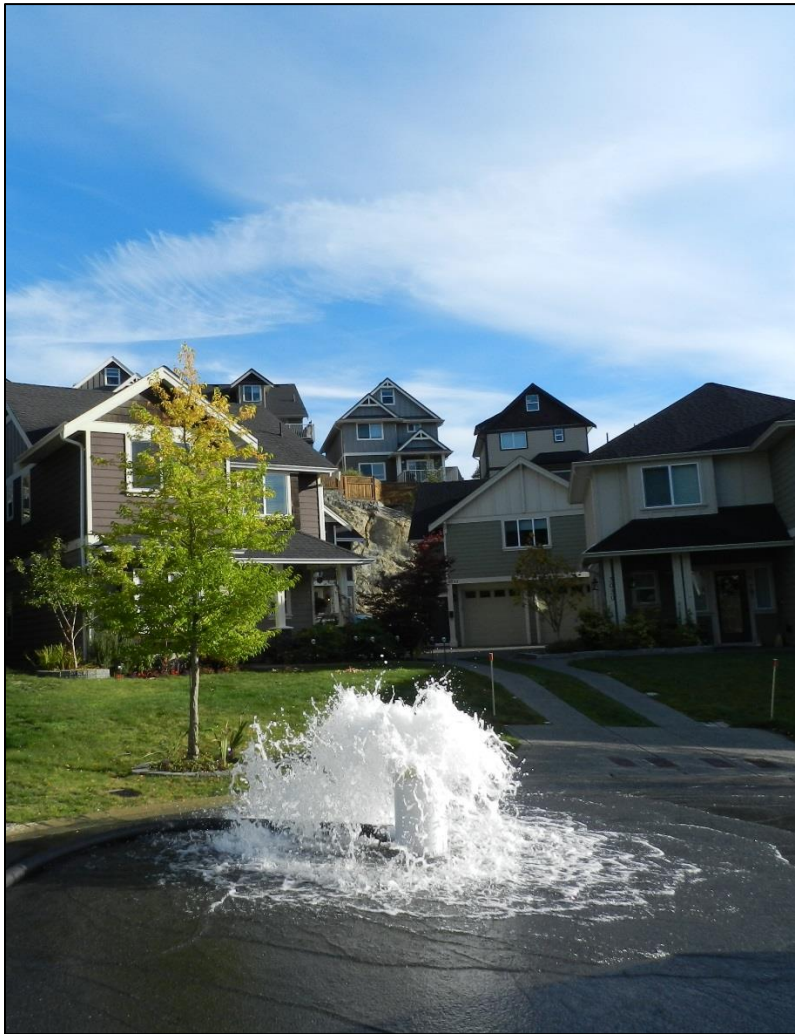
Unidirectional Flushing

- Unidirectional flushing: Full system (annual); low-demand or dead-end sections (semi-annual / as needed)
- Fire hydrants: Pressure testing, painting, physical inspection and maintenance (annual); data reported to fire department, see Appendix 2.
- Valve exercising: Open/close all system valves to confirm operational; check all box covers and arrow painting (annual)
- Water meters: Physical inspection for leaks or bypasses; add mulch for frost protection (annual)

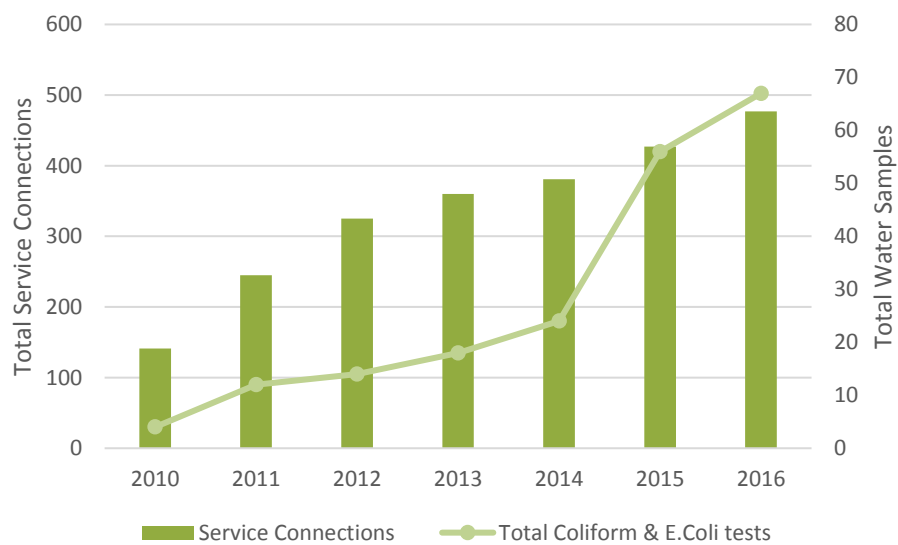
### Number of Bacteriological Samples vs Service Connections

In 2016, 12 HPC, 12 Turbidity and 67 bacteriological samples for Total Coliform and E. Coli were collected. Sampling frequency has steadily increased over the years to keep up with the ongoing growth of the Westhills Water System and community, as seen in the graph below. All samples were sent for analysis at an accredited third-party laboratory, where tests were conducted in order to detect potentially harmful parameters in the water supply.
