2017 ANNUAL WATER QUALITY REPORT

WESTHILLS WATER SYSTEM

Operated by SSL-Sustainable Services Ltd.

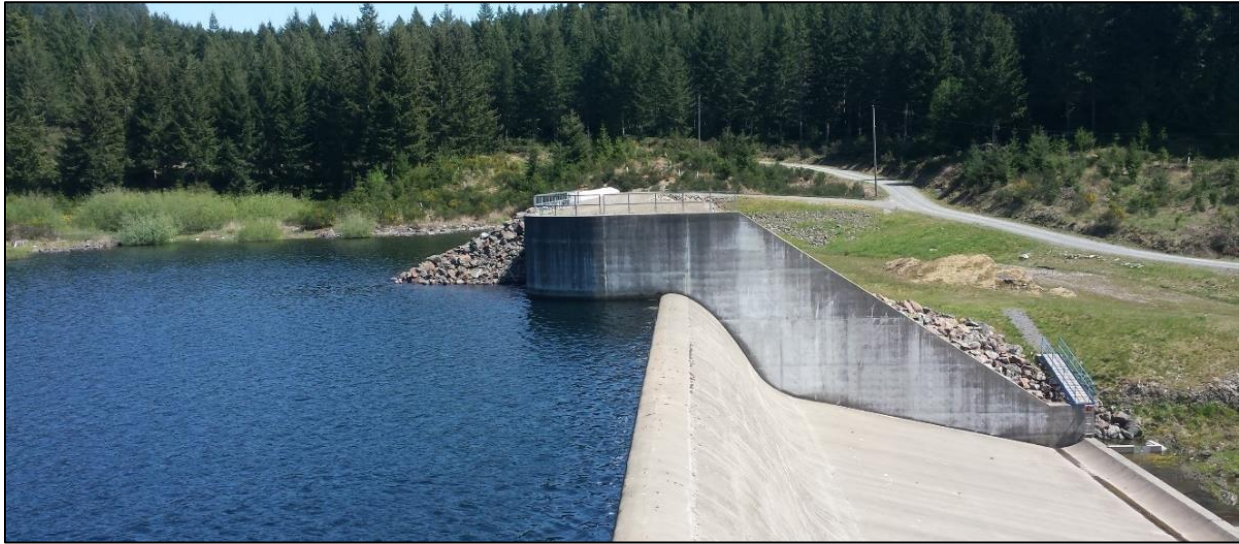
Sooke Lake Reservoir

The main water supply for the Westhills Water System is the Sooke Lake Reservoir, which also supplies water to the majority of the Capital Regional District (CRD)⁵. This water source is managed by CRD Integrated Water Services, including all disinfection and treatment processes – notably UV sterilization and chloramination.

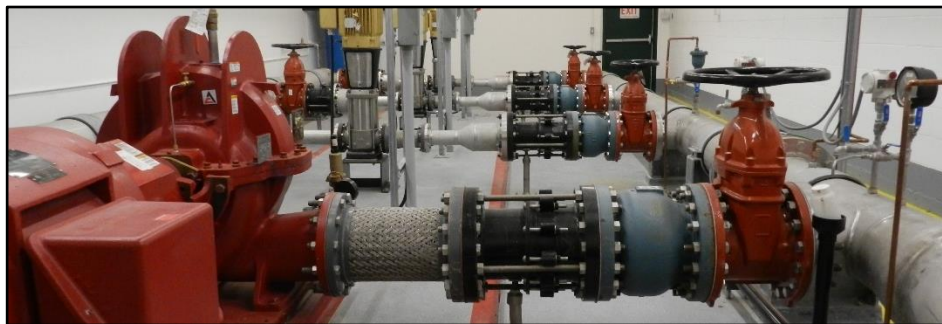
Booster Pump Station

Water is then pumped through 3 high-efficiency variable speed pumps into a distribution system servicing 487 single family homes, 50 town homes, a 68-unit condominium as well as park and public irrigation and commercial end uses. An automatic fire pump within the BPS provides fire flows when needed. The BPS also includes a standby diesel generator for emergency conditions. Fuel supply for this generator is fed from a day tank, which is in turn fed from a larger underground storage tank. An annual overview of significant water system assets can be seen in Table 1.

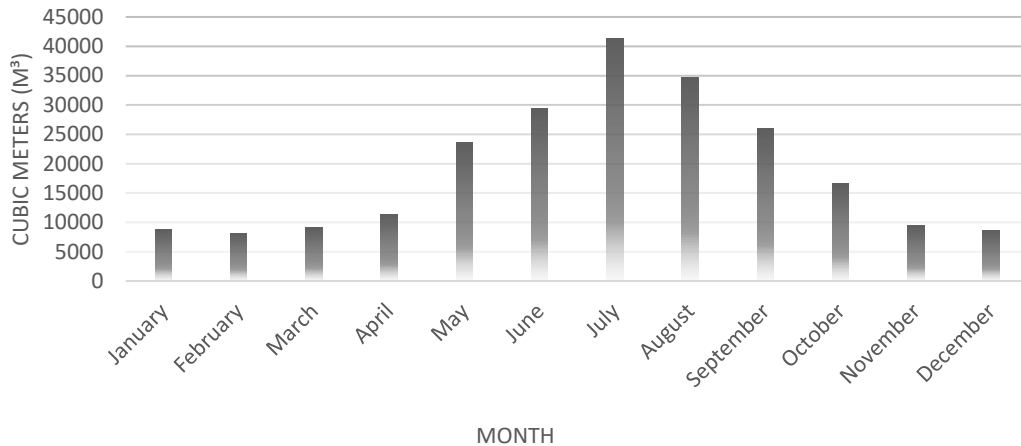
2017 Water Consumption

Like many systems, overall water usage more than triples during the summer compared to average winter levels, as seen in the graph below. Most of this increase is associated with the use of irrigation systems. As Westhills is also an ongoing land development site, large amounts of water are used during the dry summer months for construction and dust control purposes.

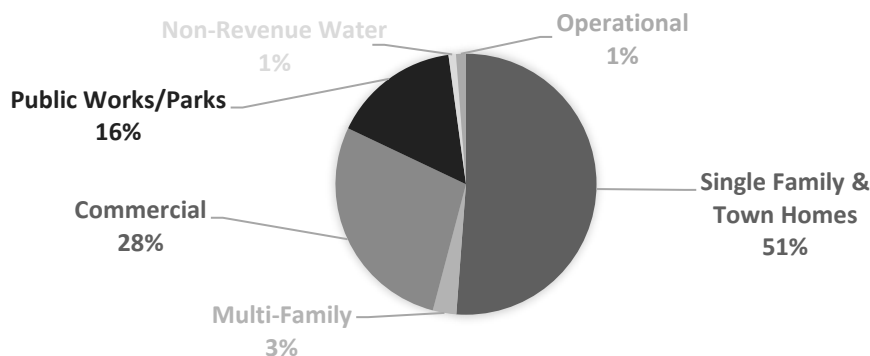
Annual Comparison

The graph below provides a breakdown by end use of all water provided in 2017. Through customer metering, SSL is able to track residential, commercial, parks and operational water usage, which accounts for most of the water that passes through the BPS. Any unidentified portion of the annual water total is classed as “non-revenue water,” including things like water leaks, error margins for estimated water billings, hydrant usage for fire department training and potentially water theft. In 2017, non-revenue water was 2,097 m³, or about 1% of total water usage in the system. This amount is significantly better than industry standards and is lower than the 2016 value of 3%.

2014	2015	2016	2017
Single Family & Townhomes	64 %	57 %	49%	51%
Multi Family	5 %	4 %	3%	3%
Commercial	5 %	13 %	26%	28%
Public Works/Parks	18 %	22 %	18%	16%
Non-Revenue	6 %	1 %	3%	1%
Operational	2 %	2 %	2%	1%

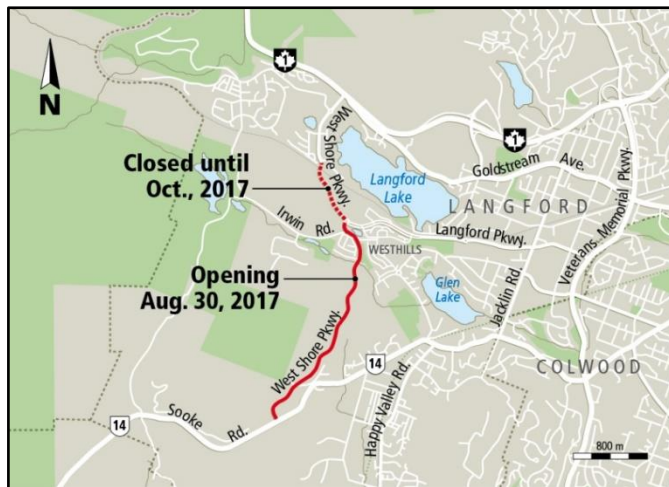
West Shore Parkway⁶

Much of this growth is attributable to the West Shore Parkway road extension project, which was completed by the City of Langford in late 2017. This project represents a significant expansion to the existing Westhills Water System, including new water mains which now extend to large areas of previously underserved land to the south, near Sooke Road.

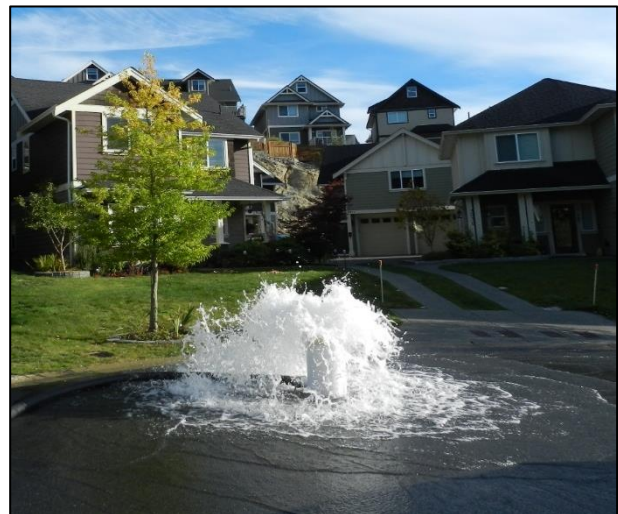
Unidirectional Flushing

- Unidirectional flushing: Full system (annual); low-demand or dead-end sections (semi-annual / as needed)
- Fire hydrants: Pressure testing, painting, physical inspection and maintenance (annual); data reported to fire department, see Appendix 2.
- Valve exercising: Open/close all system valves to confirm operational; check all box covers and arrow painting (annual)
- Water meters: Physical inspection for leaks or bypasses; add mulch for frost protection (annual)

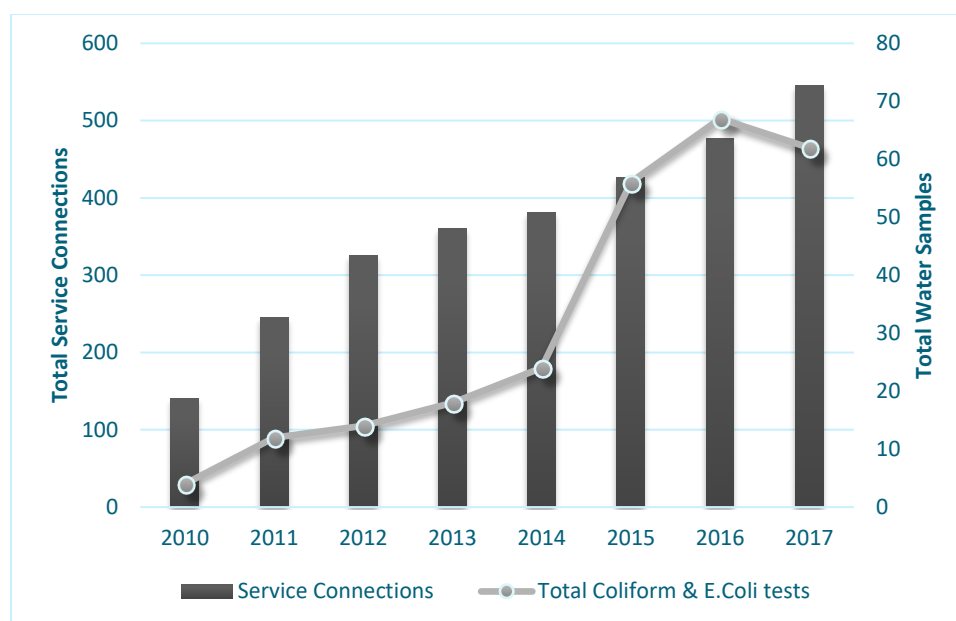
Number of Bacteriological Samples vs Service Connections

In 2017, 12 HPC, 12 Turbidity and 62 bacteriological samples for Total Coliform and E. Coli were collected. Sampling frequency has steadily increased over the years to keep up with the ongoing growth of the Westhills Water System and community, as seen in the graph below. All samples were sent for analysis at an accredited third-party laboratory, where tests were conducted in order to detect potentially harmful parameters in the water supply.

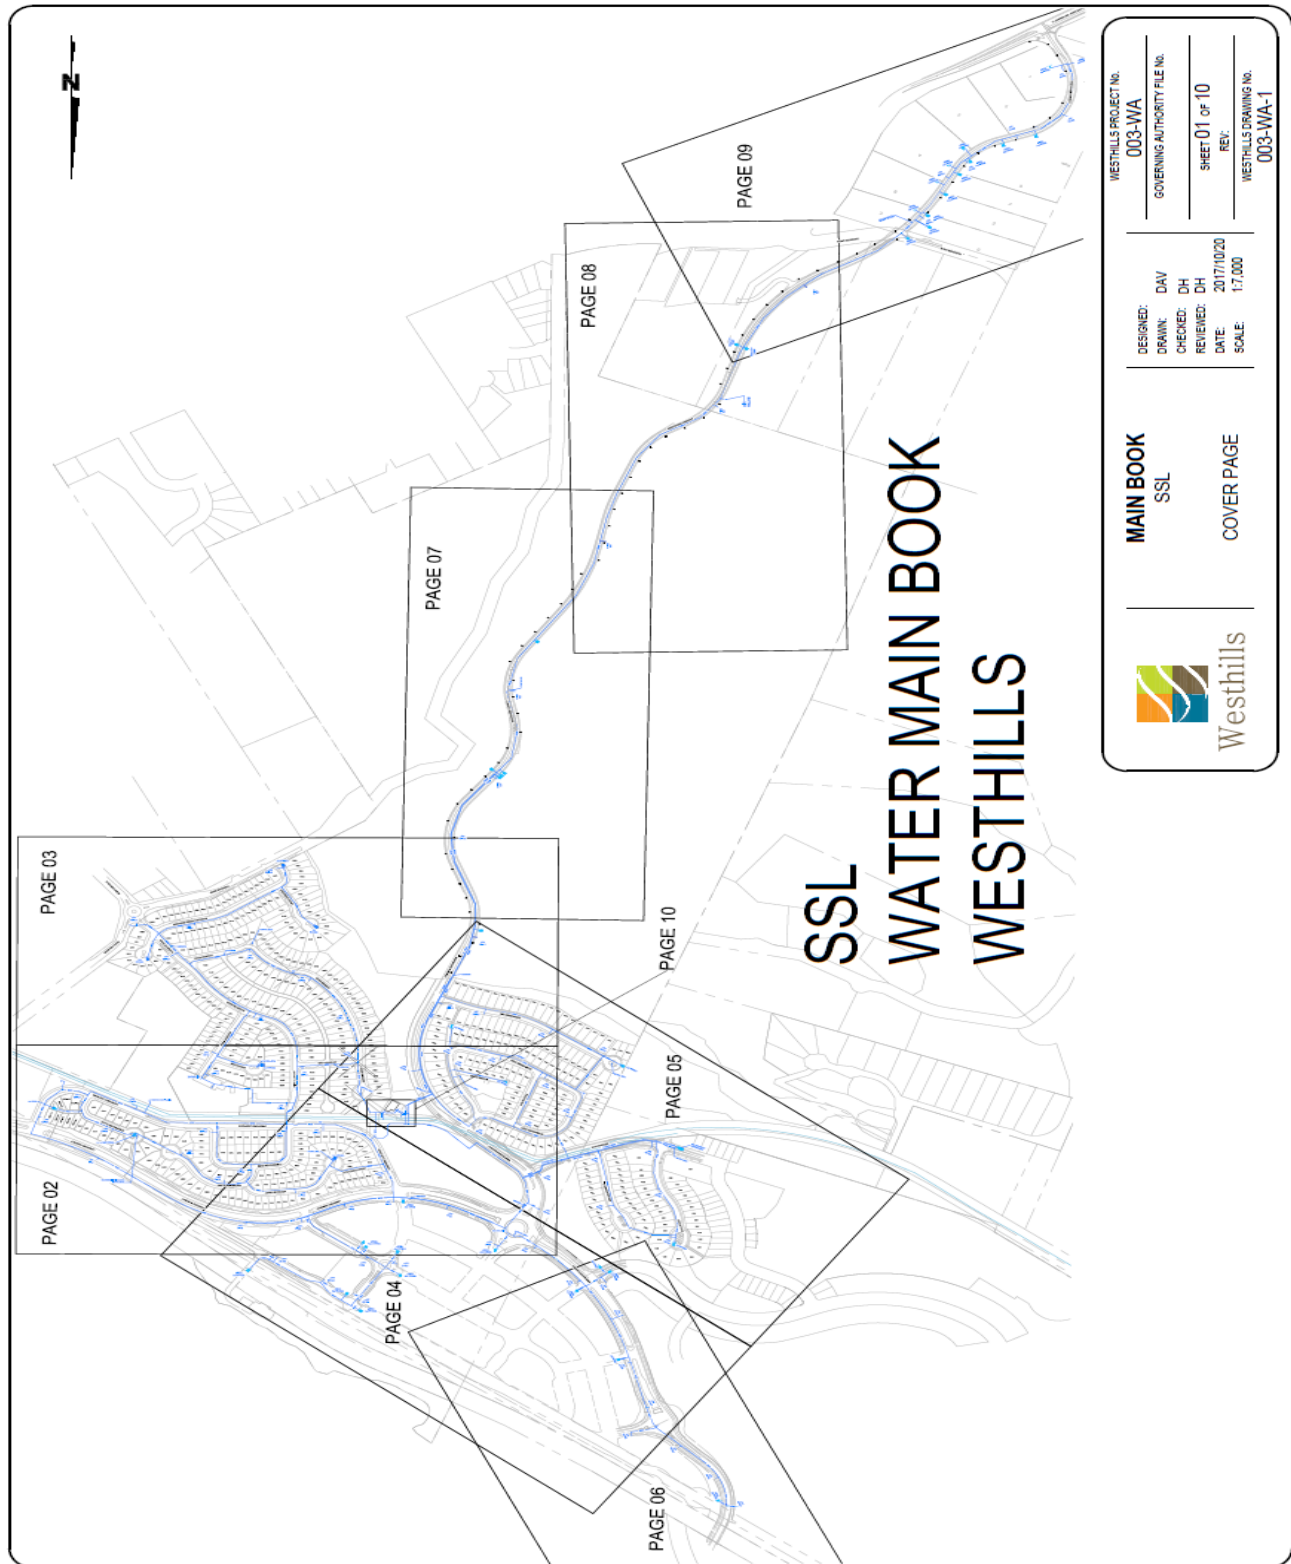
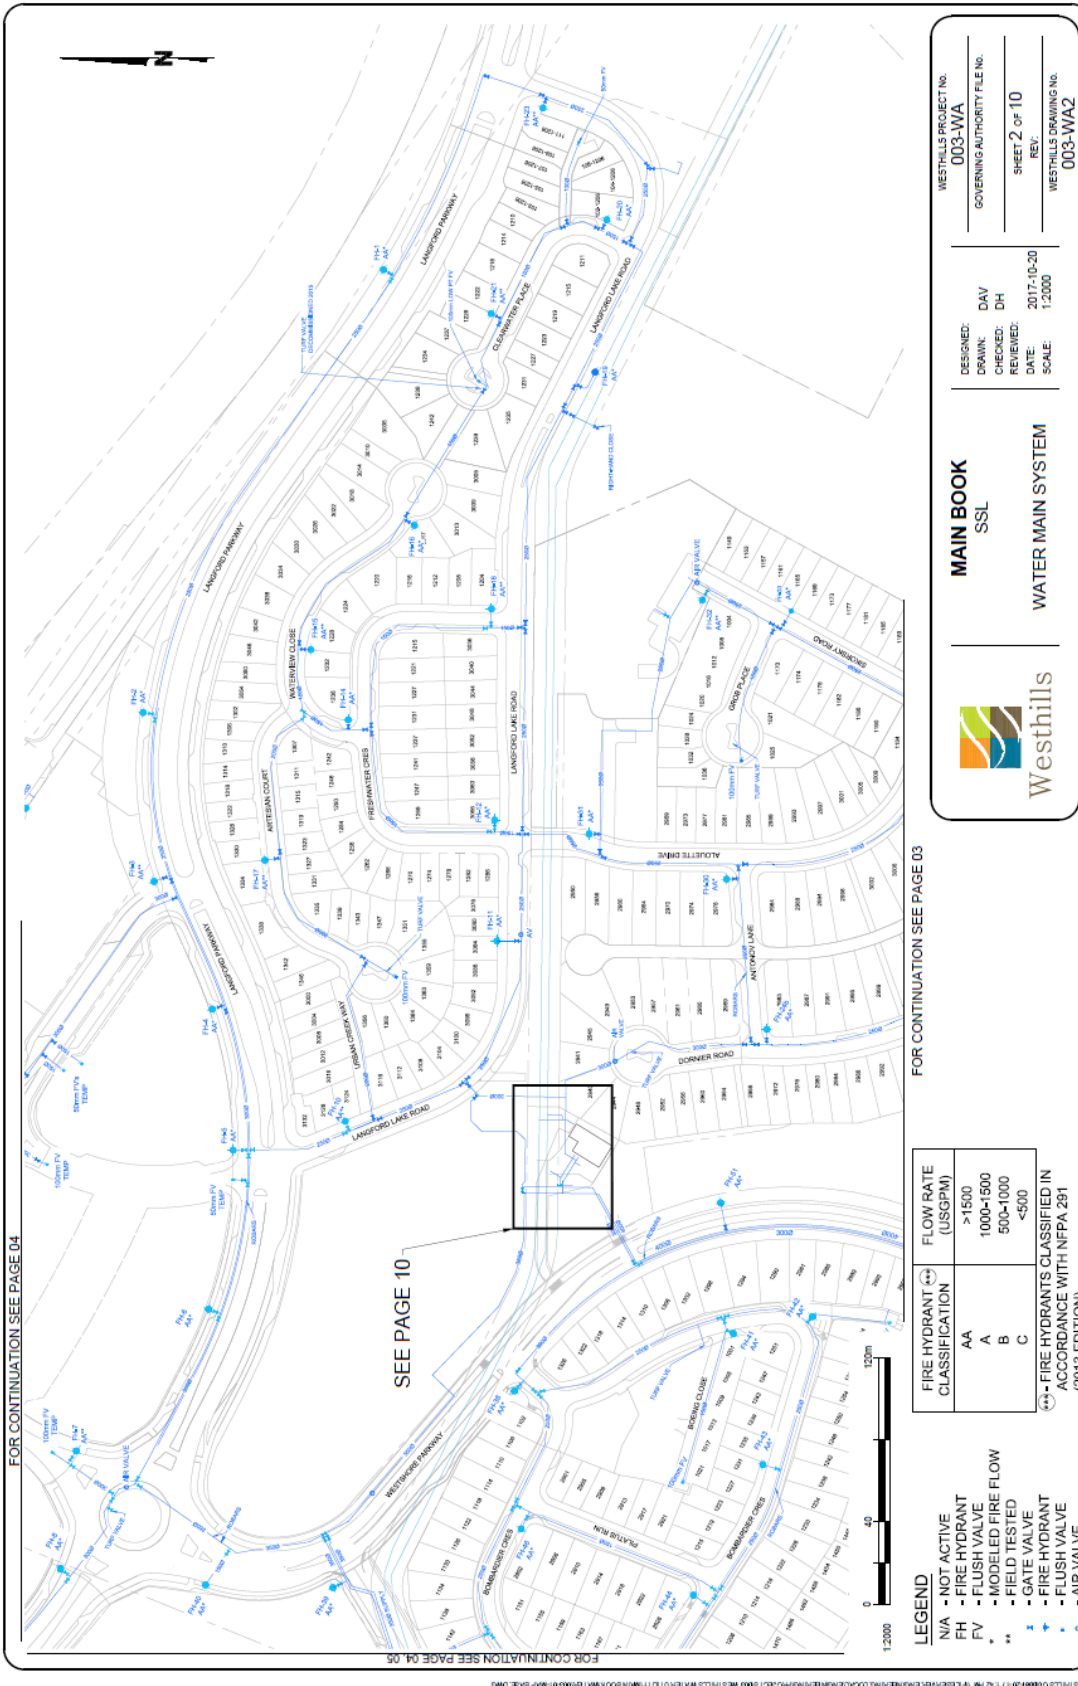
Appendix 1: SSL Water Main Book

WATER MAIN SYSTEM

1-2-3-4-5 - FIRE HYDRANTS CLASSIFIED IN ACCORDANCE WITH NFPA 291 (2013 EDITION)
